## **AVIATION INVESTIGATION REPORT**

**A04P0240**

### **BLADE STRIKE AND ROLLOVER**

**EUROCOPTER AS350 B2 (HELICOPTER) C-GSHH**

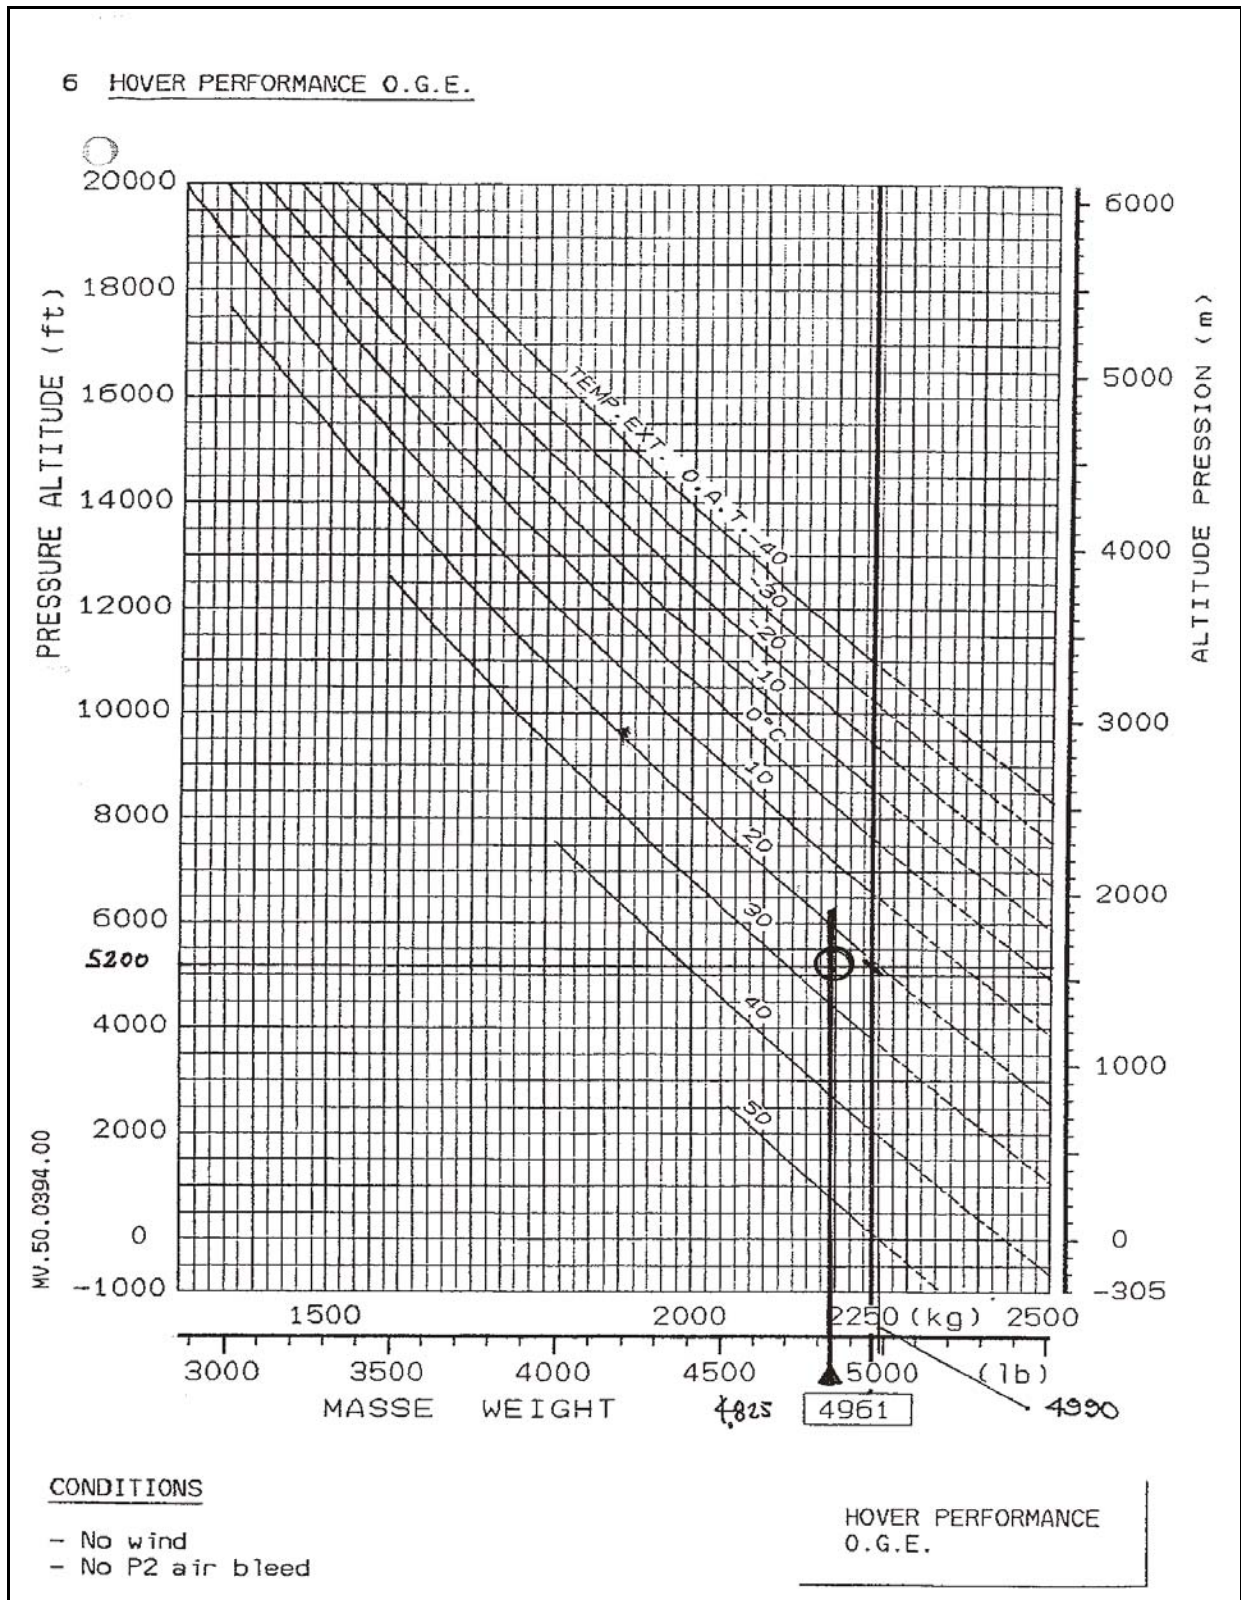
# Appendix A – Hover Performance Out-of-Ground-Effect

Using the HOGE curves (see Appendix A), assuming an outside air temperature of 20°C, a pressure altitude of 5200 feet, and a gross weight of 4825 pounds, at the second take-off attempt the helicopter was approximately 150 pounds less than the maximum weight permitted for those conditions. As ambient air temperature increased to 25°C, this margin would have been progressively eroded to zero. The actual performance of the helicopter would also have been affected by several other factors, including wind and wind gusts, pilot handling techniques, and engine and rotor system efficiency.
